## Investigations into history of Mr Fletcher's House (Toddington Florist)

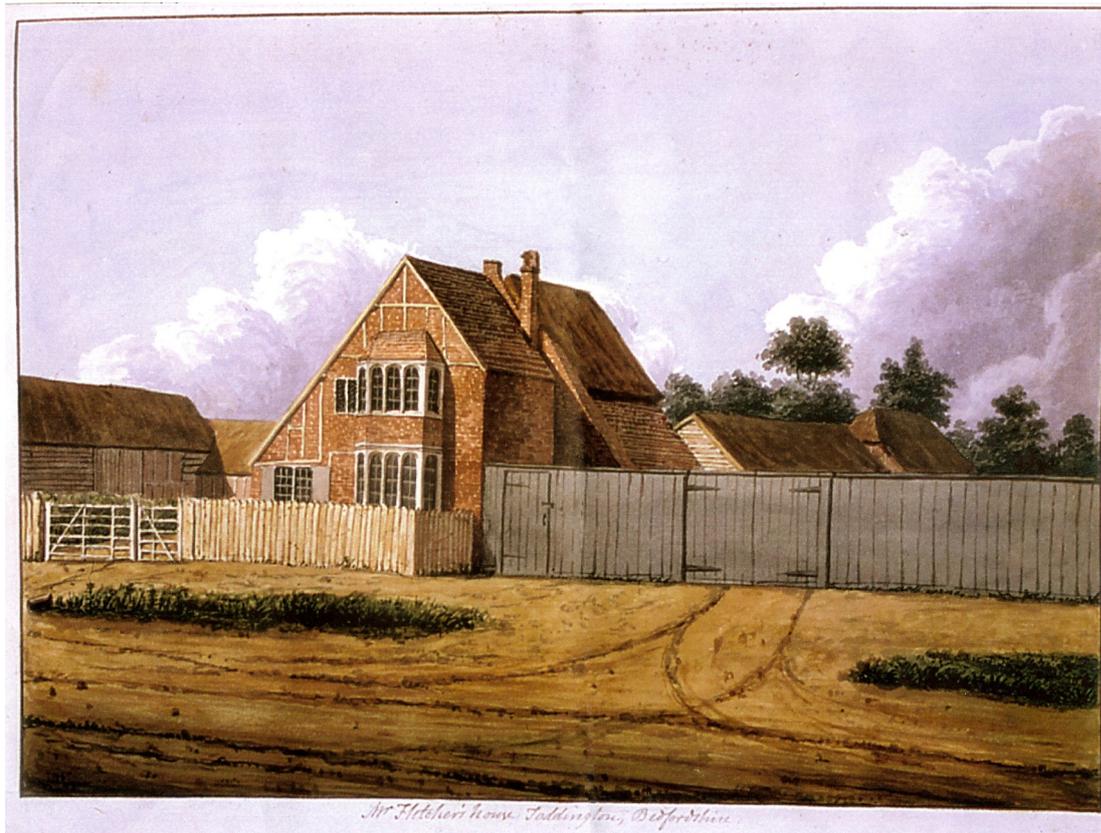
How did this 1820 painting of Mr Fletcher's House by Thomas Fisher become the 2011 photo of same view below?

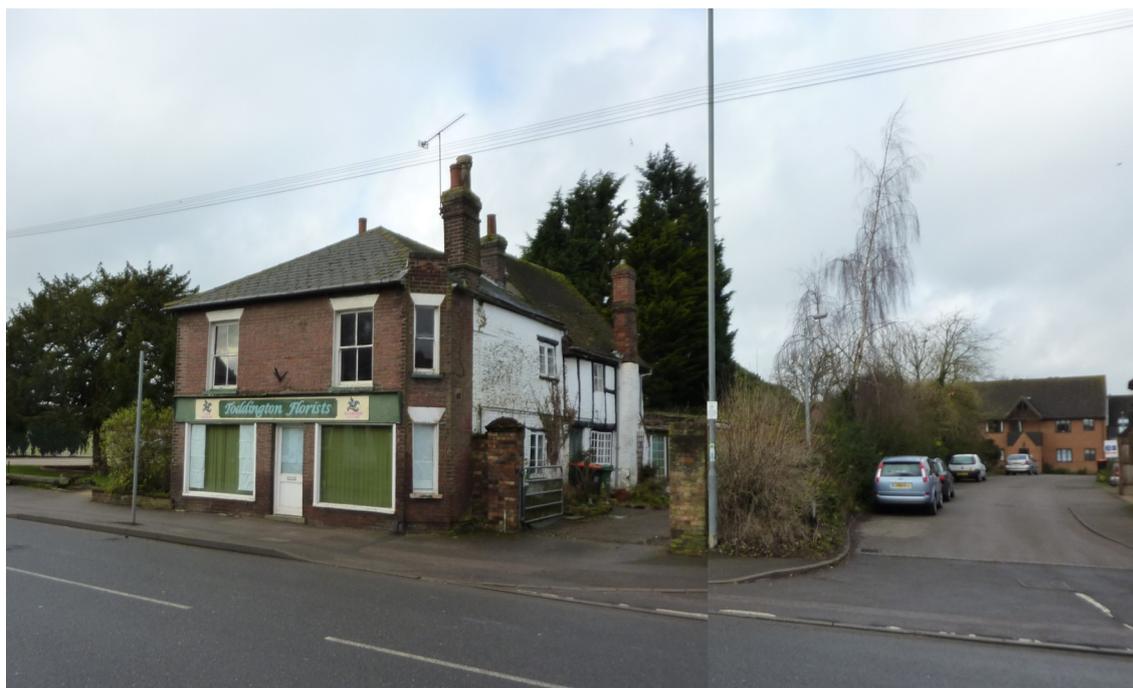
Initially they look so unrecognisable as the same property ! Although Steve Southin, who provided the above painting photo, was certain. I set out to investigate further

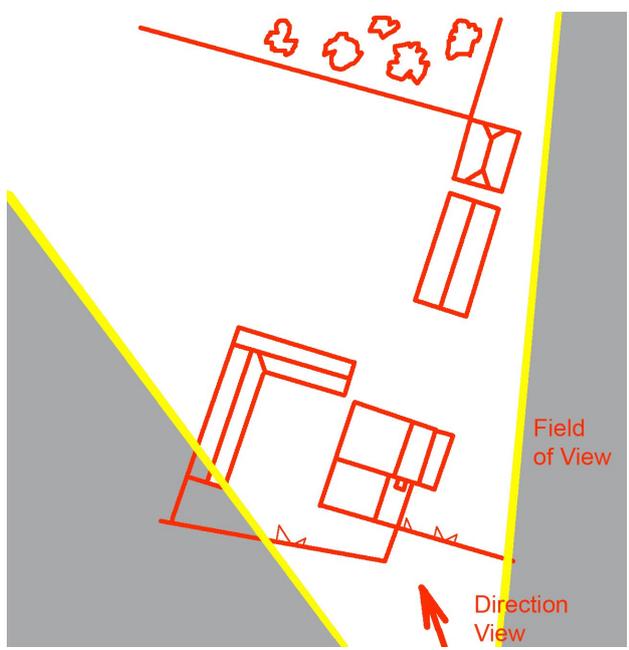
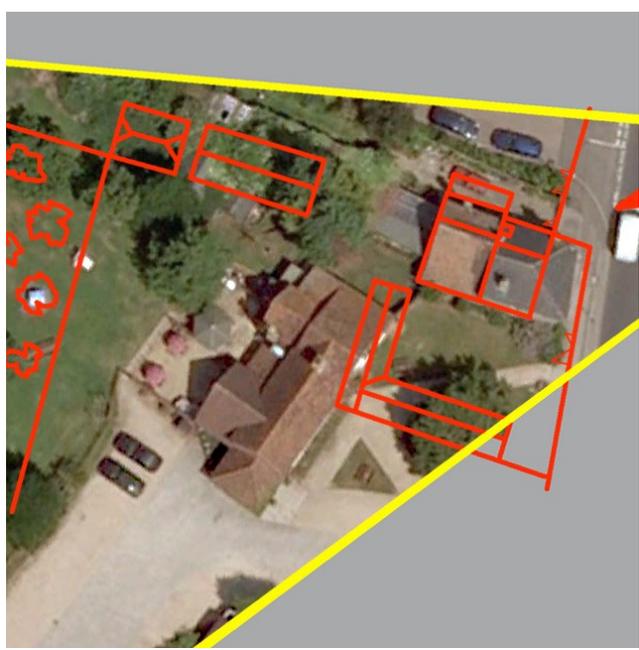
Next, being an architect, I imagined a scale plan of the property in the painting and the angle of vision of the painting as thus, Then rotated it and superimposed it on a Google Earth view:

It fitted with front smaller than present, we knew the front had been re-built and had been brought to the road as with many High Street Properties even my own.

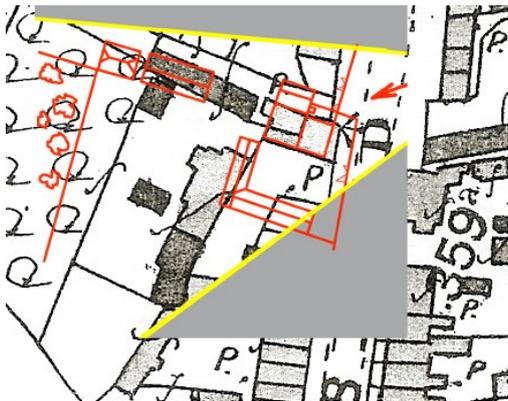
Next we looked to the 1882 map and superimposed the same red plan:

Again an excellent match. The rear line of trees boundary was a little out but the trees were there, just error in my estimate of depth.

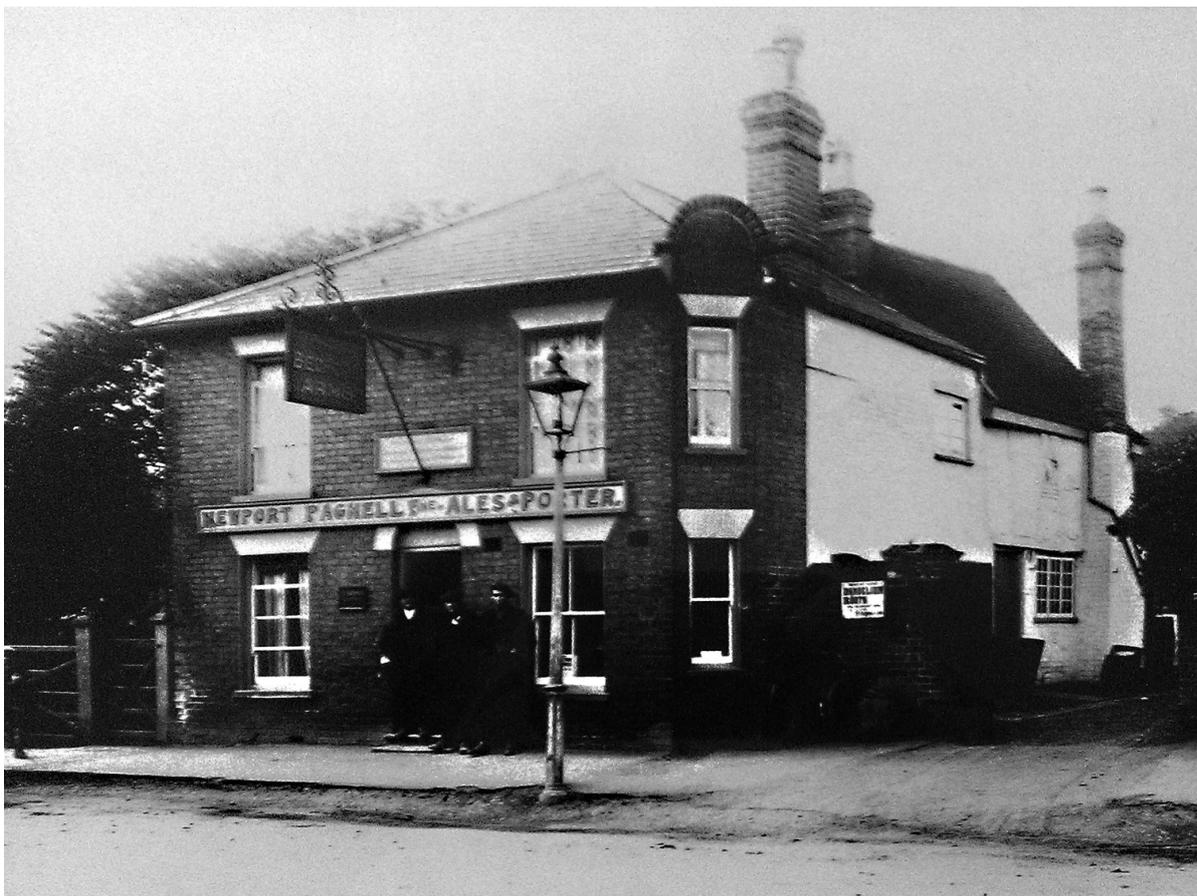
Then we came to the old photo of when it was a pub. Although the gates on far left have been replaced they are identical to one passenger gate and one vehicular gate as shown on the left of the painting. We have another match!

On close real inspection one can see the right hand chimney is later bricks and has been added probably about 1870, such was the fashion. The nearest chimney is on the re-modelled front but the chimney to the right of this is showing on the 1820 painting in the same position.

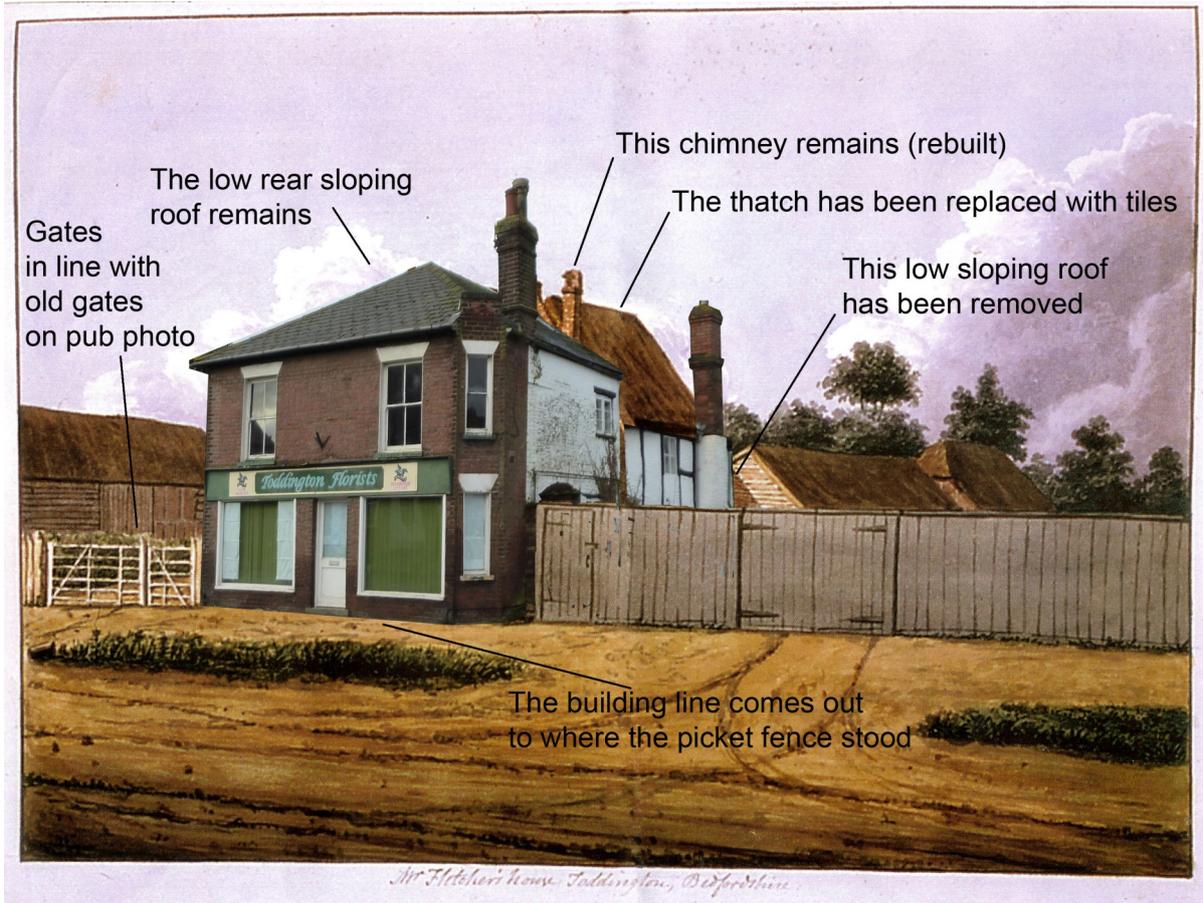
Lets look at a mock-up of Fisher's 1820 painting and we can visualise how this all came about:

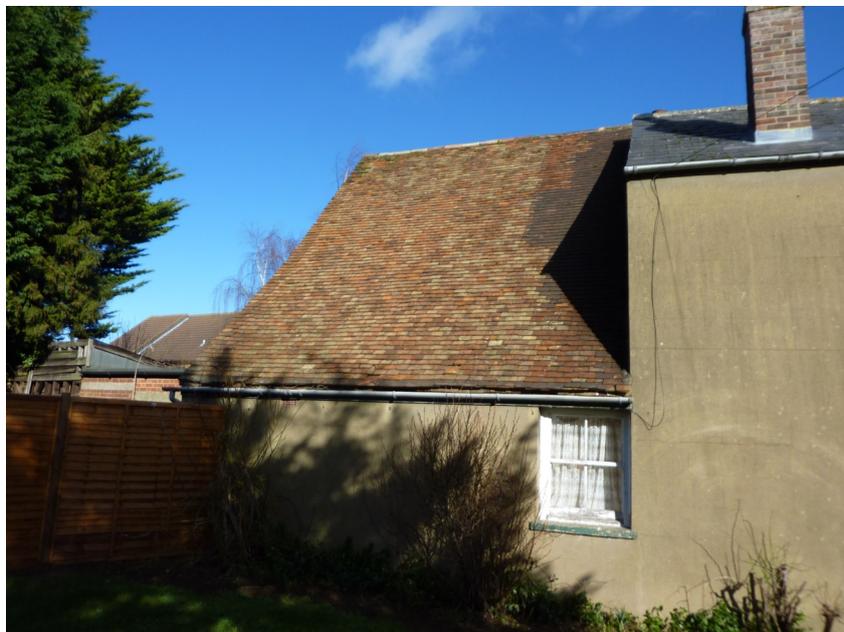
A photo of the out-of-sight rear sloping roof which used to carry through to the front on the 1820's painting.
